# INSPECTION REPORT

For the Property at:  
**135 SUTTON STREET**  
FREDERICTON, NB E3B 6L4

Prepared for: RASHMI HAWLEY & TUSHAR PISHE  
Inspection Date: Wednesday, February 21, 2024  
Prepared by: Dan Ferguson

RE: Report No. 1221  
135 Sutton Street  
Fredericton, NB  
E3B 6L4

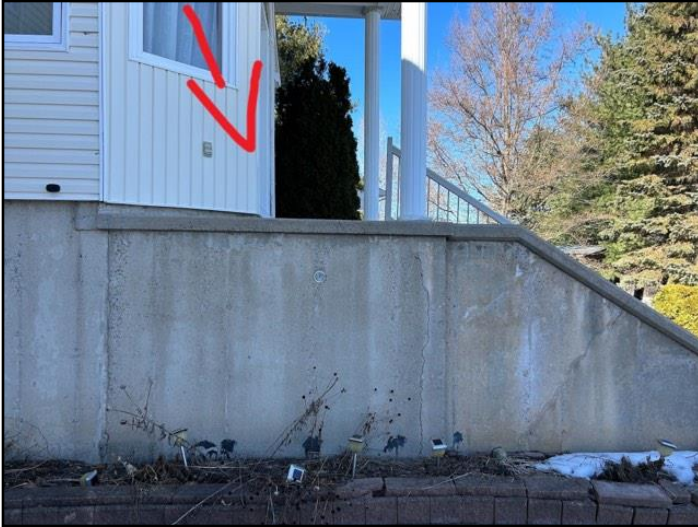
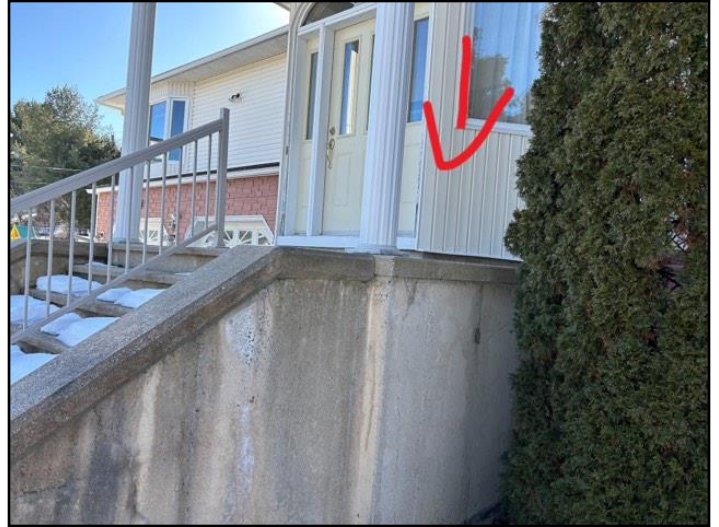
1. **Condition:** • Railing required at front entry area for safety.

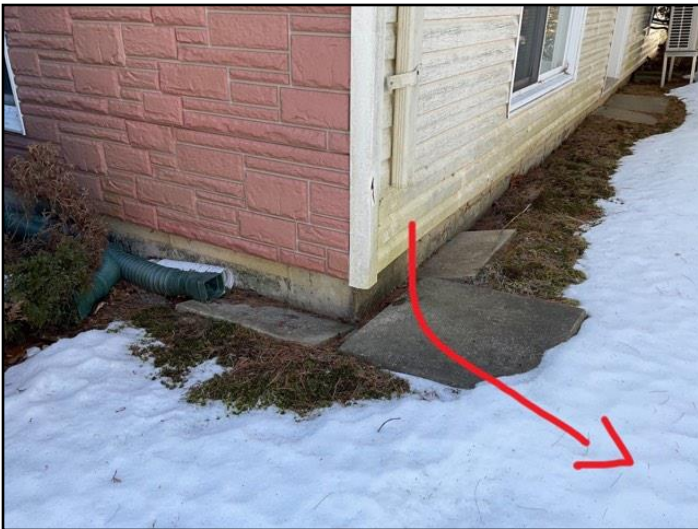
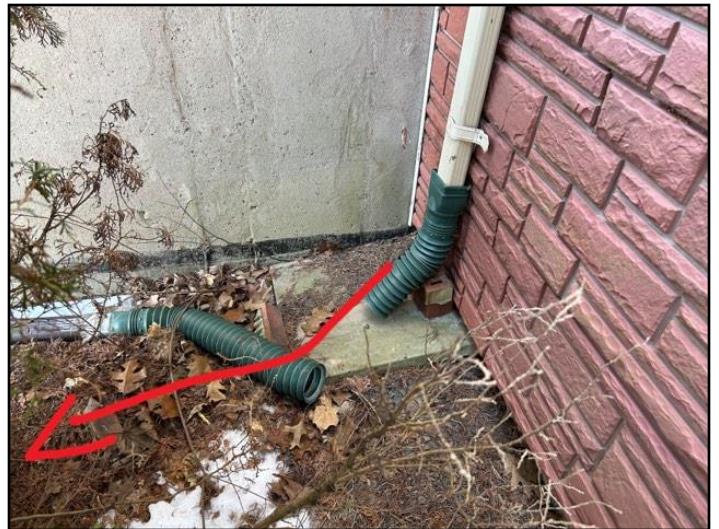
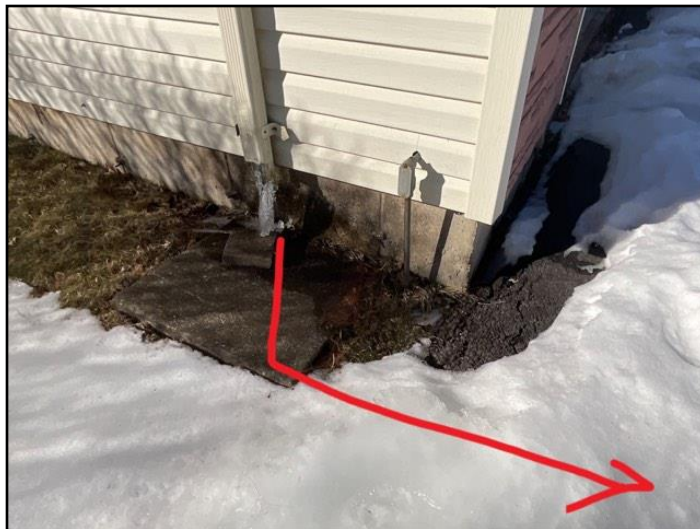
2. **Condition:** • Add downspout extensions to get water away from foundation walls. Excessive water by walls will cause water infiltration to basement.

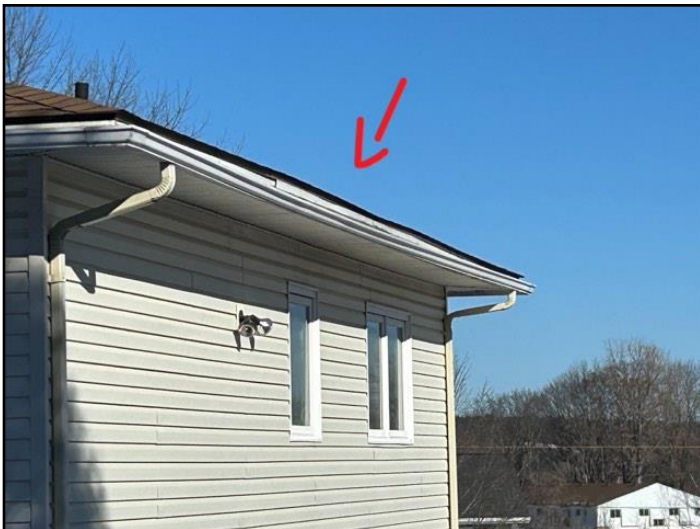
9.

3. **Condition:** • Gutters dipped at front and left side. Spillage noted. Have corrected.

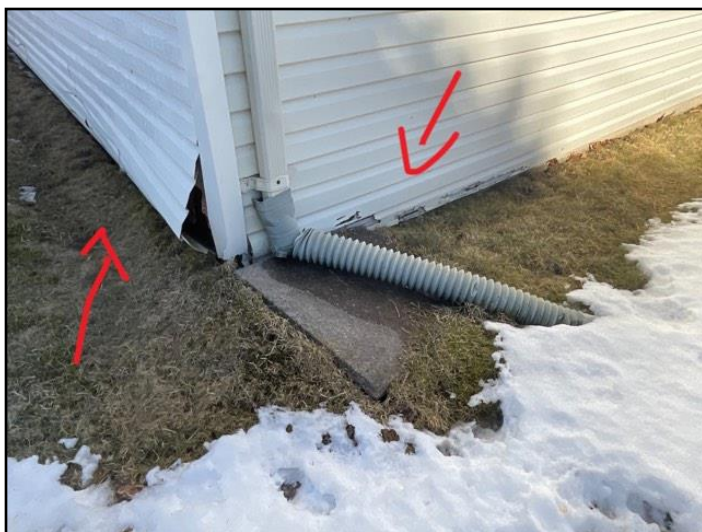
11.

4. **Condition:** • Siding at back left side of house damaged from frost heaving. This has opened up wood behind siding to water damage.  
Have this repaired.

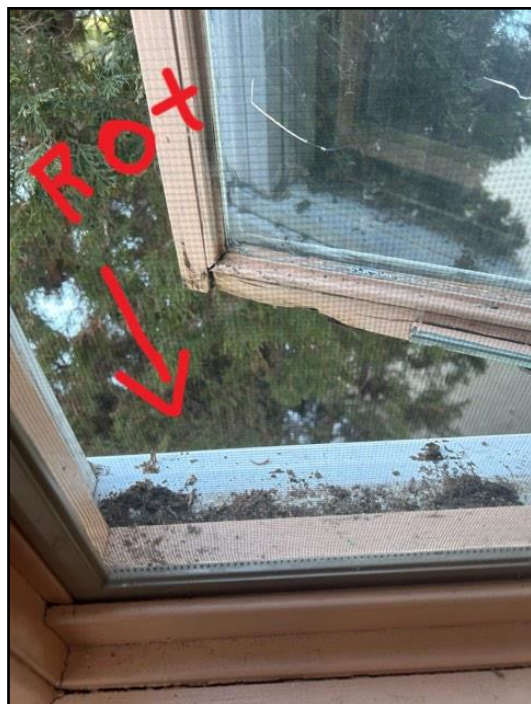
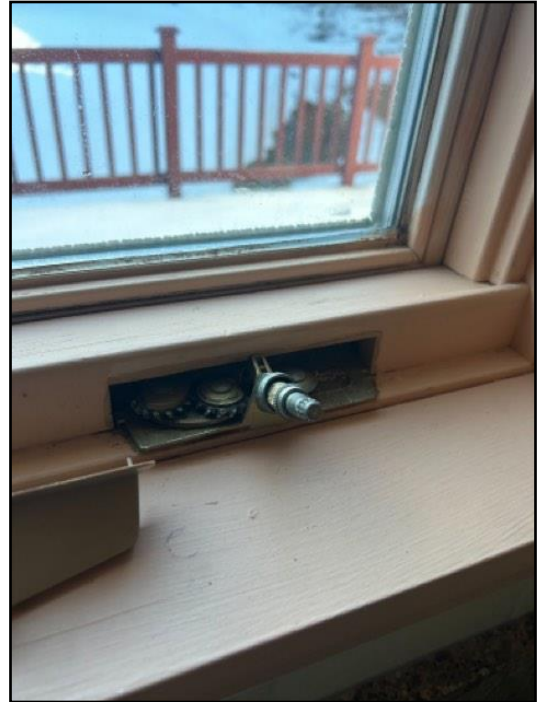
**5. Condition:** • Original windows in home. Some damaged, multiple seals failed, rotted and opening devices don't work. Budget for future replacement of windows in house. Get estimates.

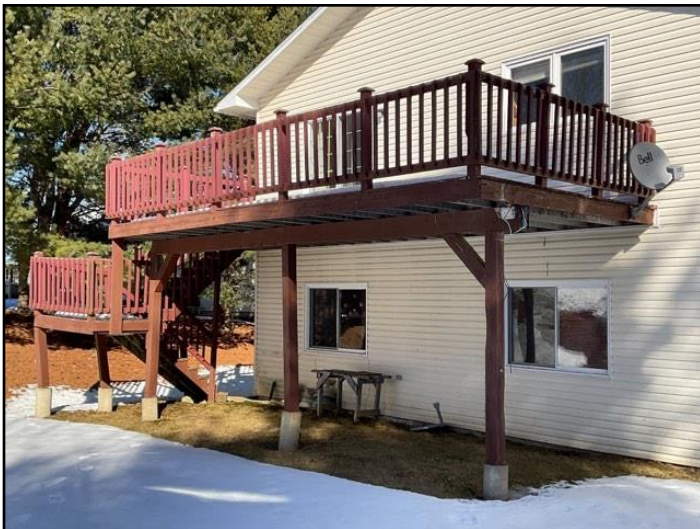
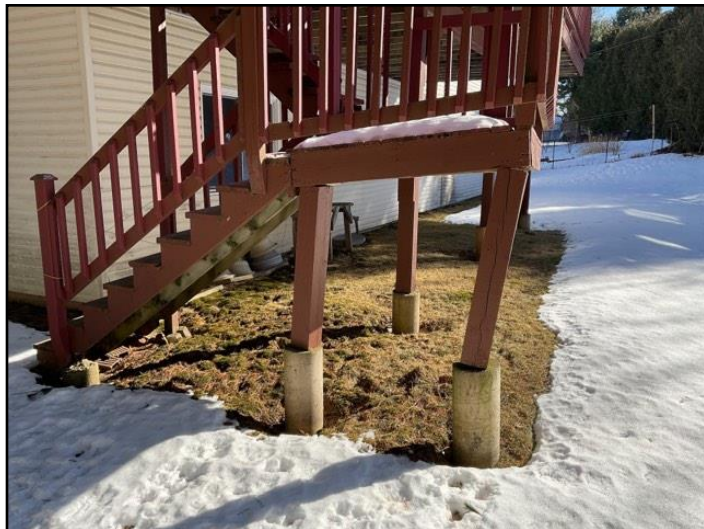
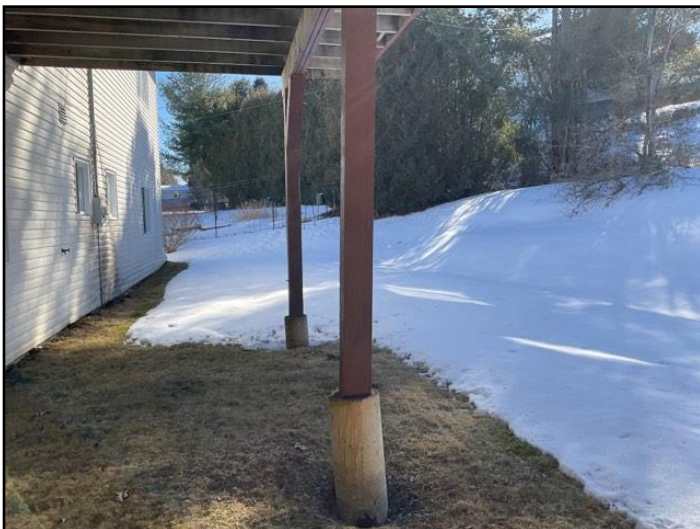
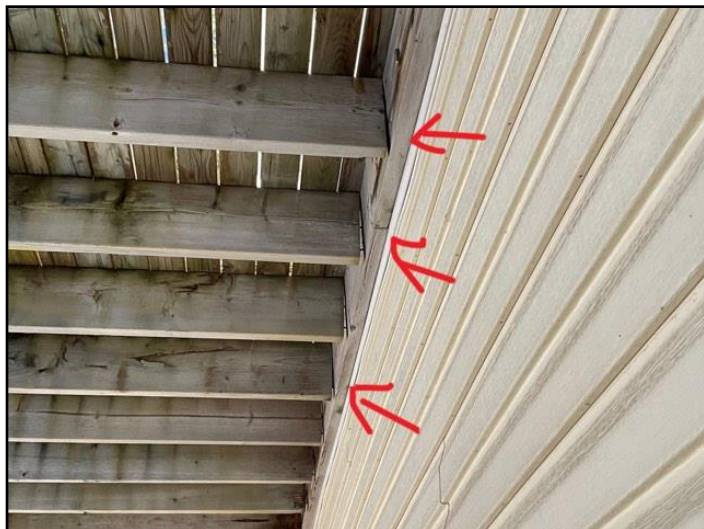
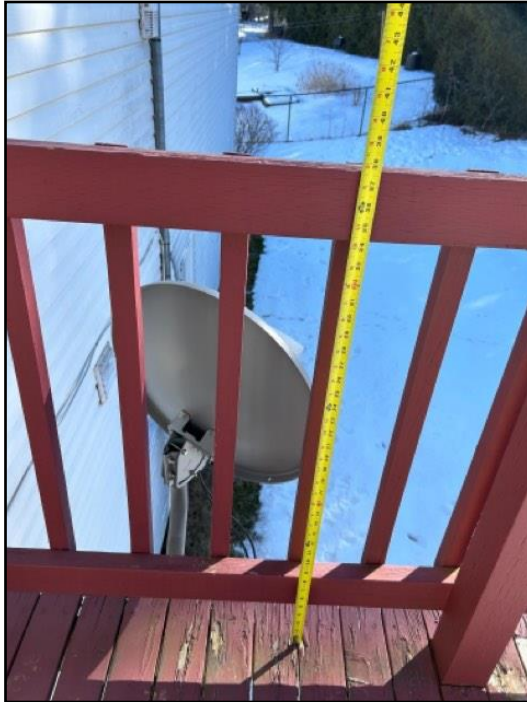
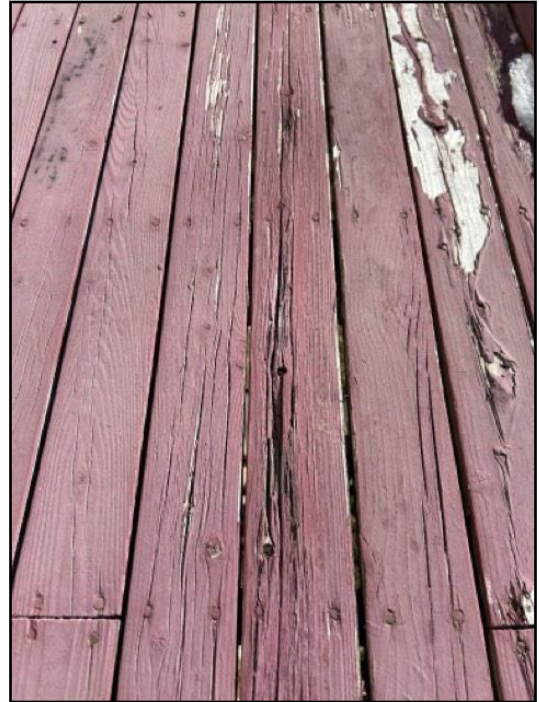
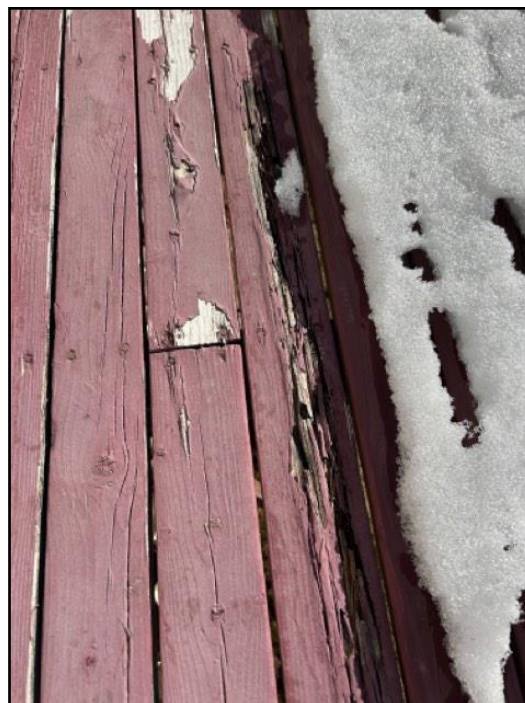
### 7. Condition: • Unsafe

Back deck stairs not safe to walk on. Failure to structural support.

Deck along with ground support needs replacing.

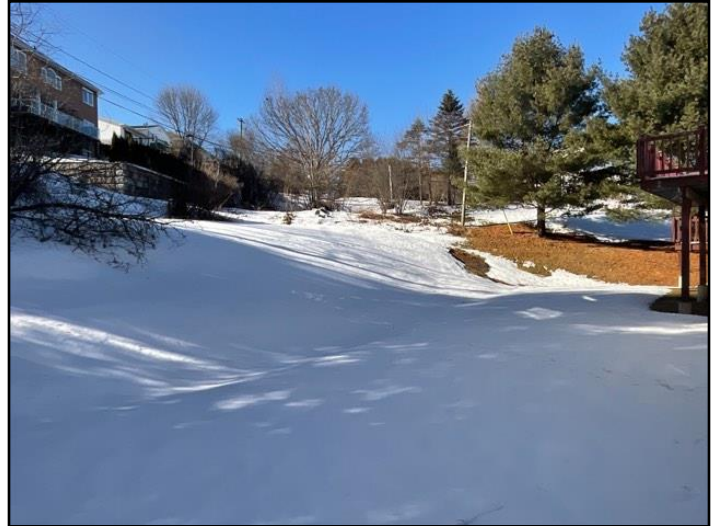
26.

**8. Condition:** • Large hill at back. Be aware when water drains towards house it raises potential for basement leaks and frost movement.

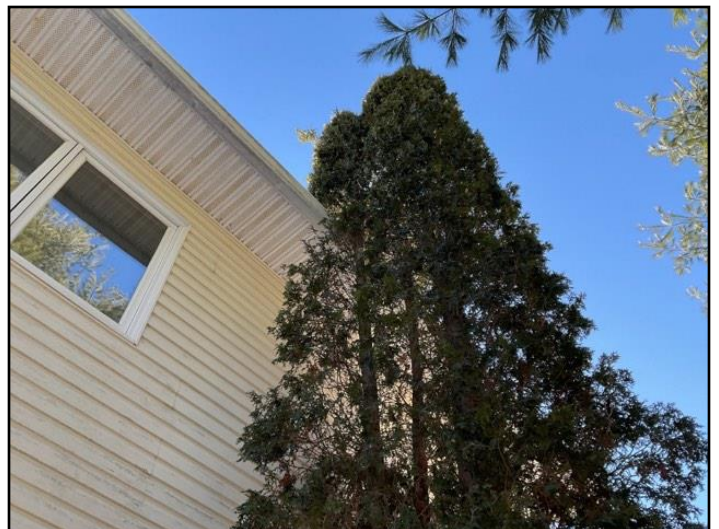
28.

**10. Condition:** • Lower soil down from siding where touching. This has allowed frost to push up siding at back left corner.

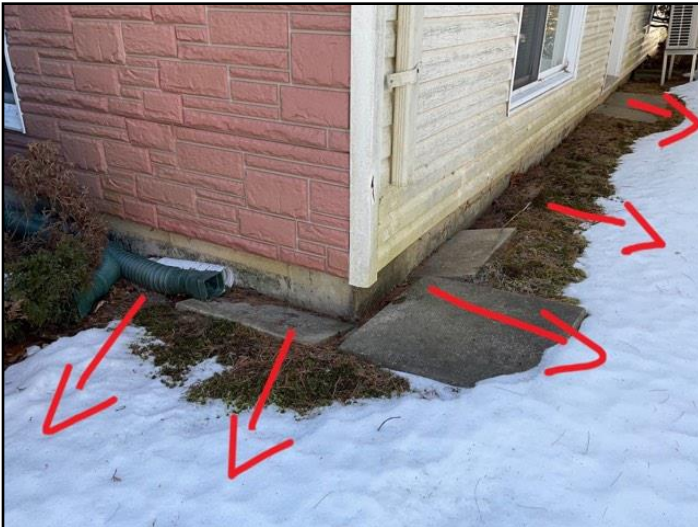
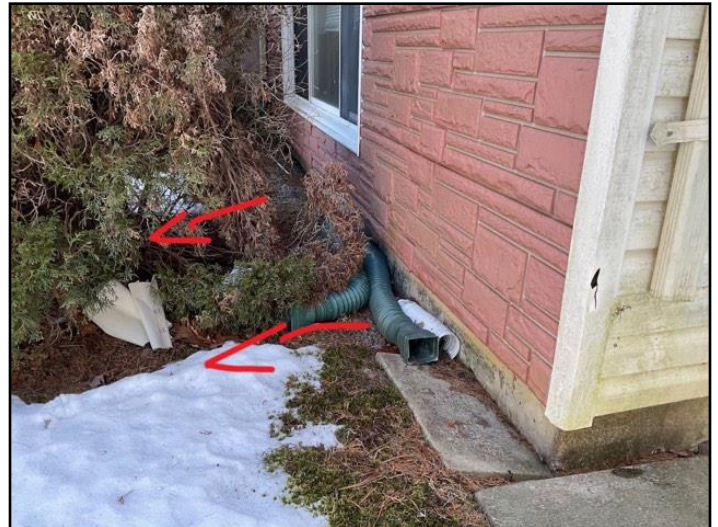
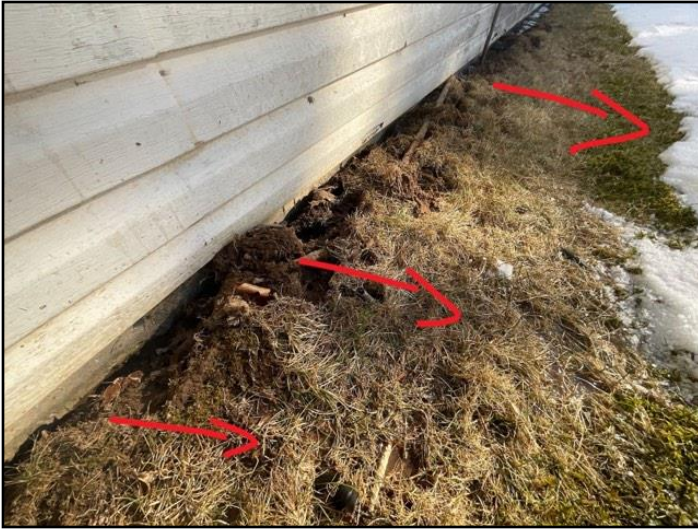
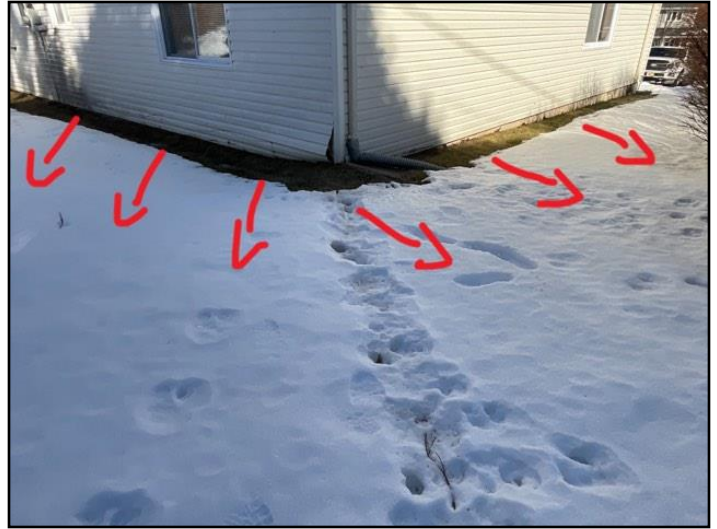
• Grade should be slopped away from foundation walls of home to allow proper drainage. If water sits by walls it raises potential for leaks and dampness in basement. Suggested to have any low areas re-graded for proper drainage away from walls.

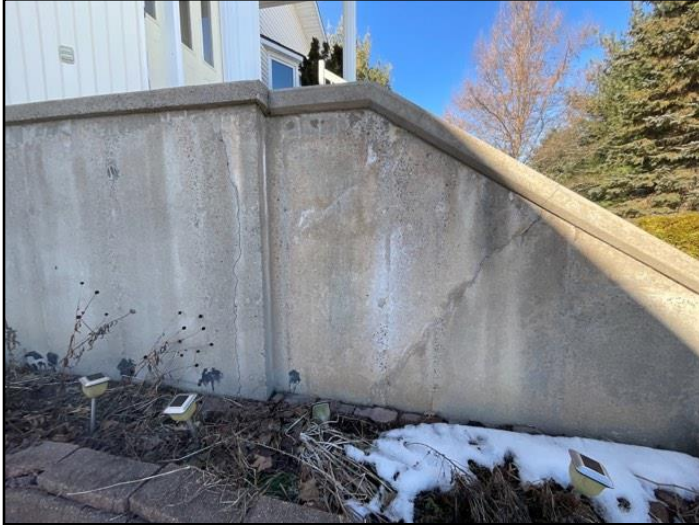
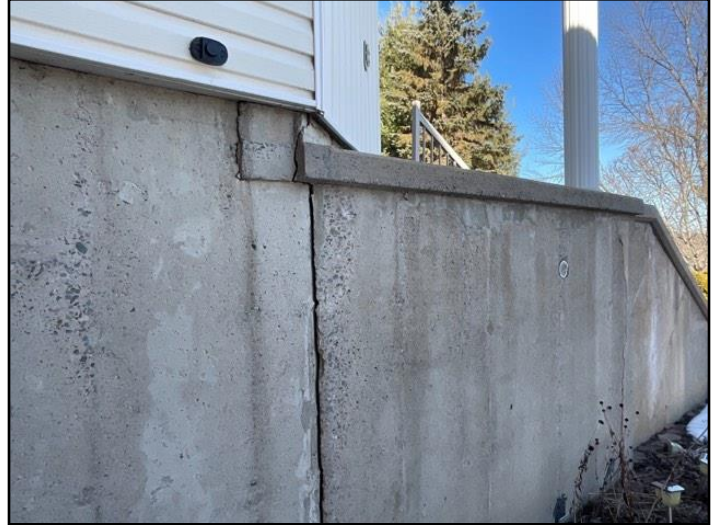
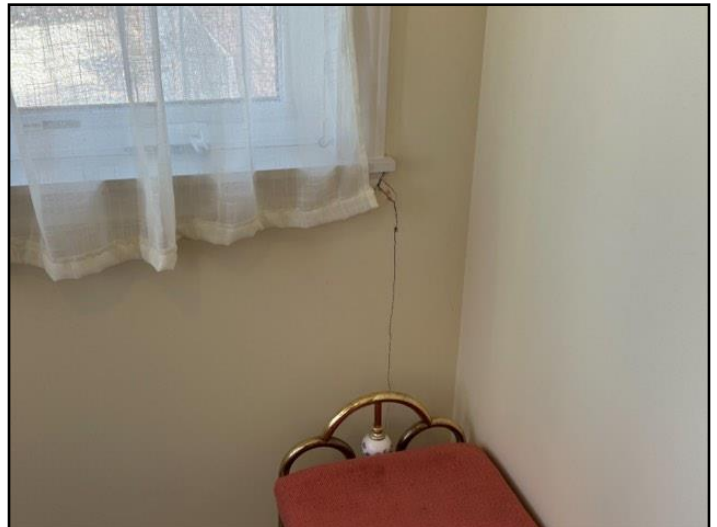
Concrete front step area shows signs of settling. Cracking.

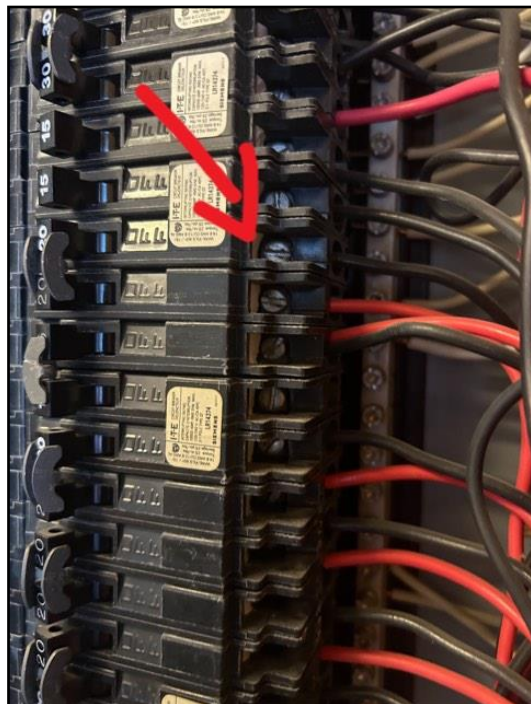
51.

14. Condition: • Double tapped breaker noted in panel.

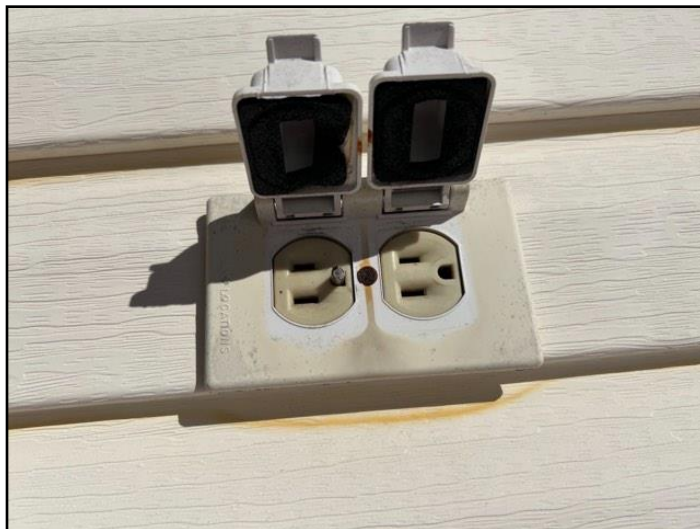
53.

15. Condition: • Replace back deck plug.

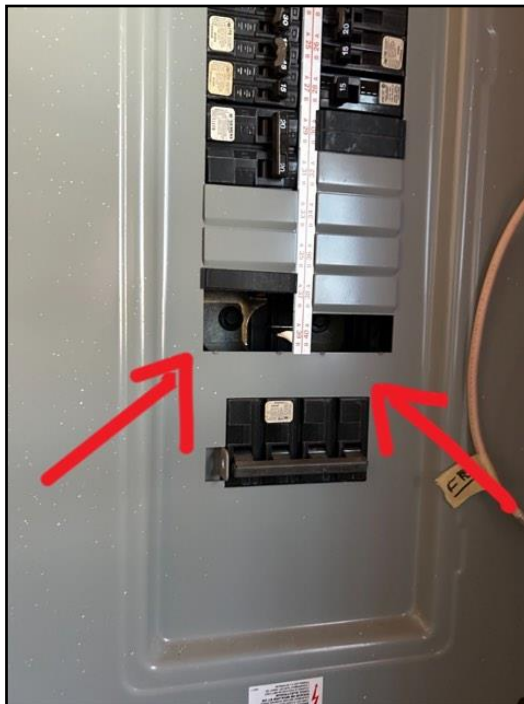
54.

16. Condition: • Add missing knock out breaker covers at panel for safety.

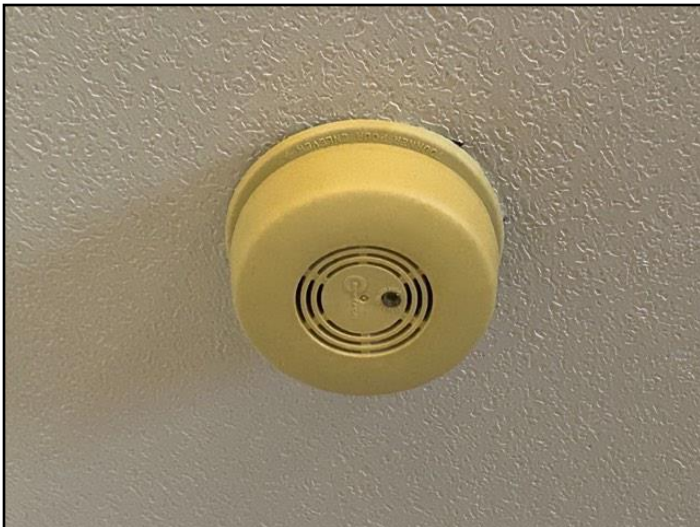
**DISTRIBUTION SYSTEM \ Smoke alarms (detectors)****17. Condition:** • Past life expectancy

Replace smoke detectors.

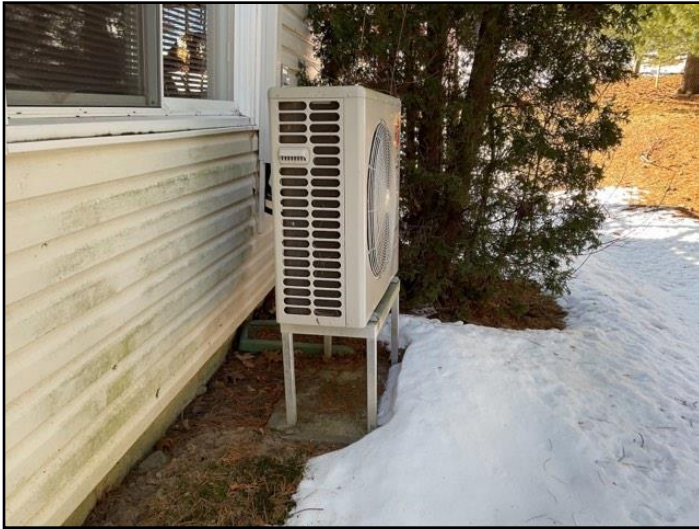
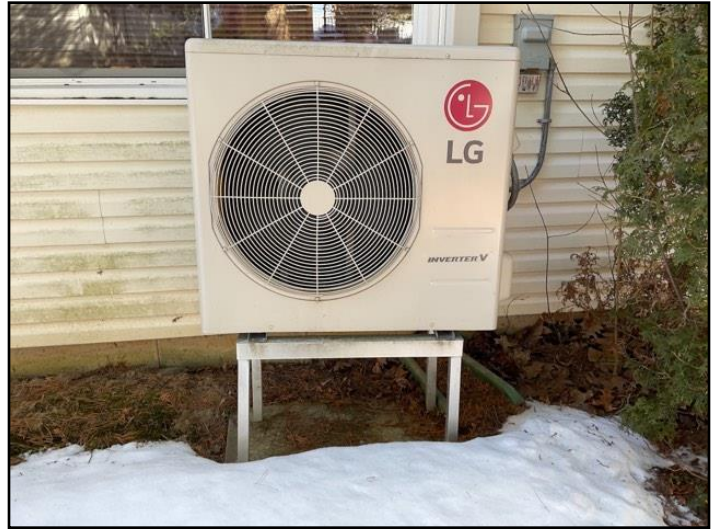
#### 19. Condition: • Service heat pump

Heat pump compressor noisy at time of inspection and exterior unit off level. Have this corrected. Have new ground support added.

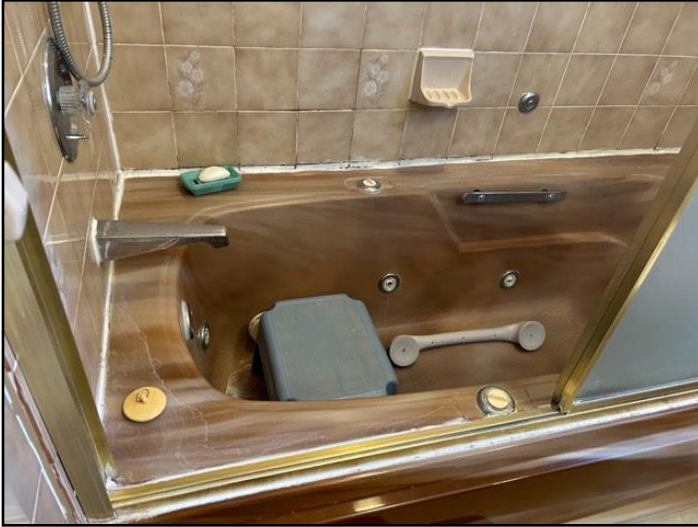
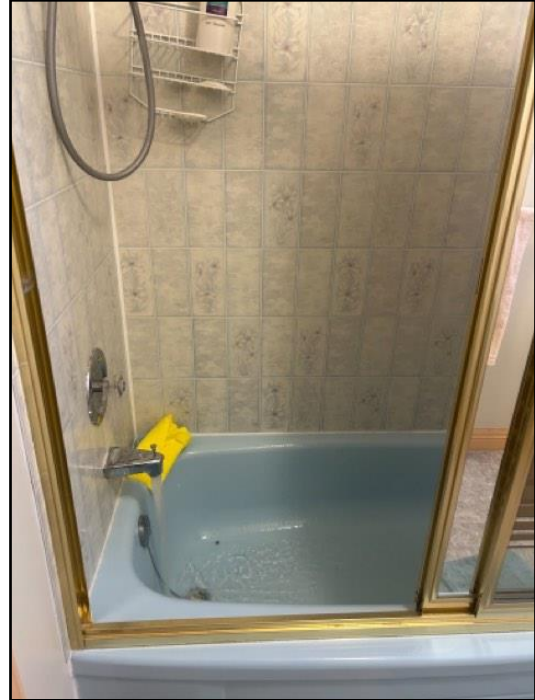
**20. Condition:** • Tubs, surrounds, sinks and toilets dated in home.

Due for replacement. Budget for possible water damage behind shower surrounds with tile on walls.

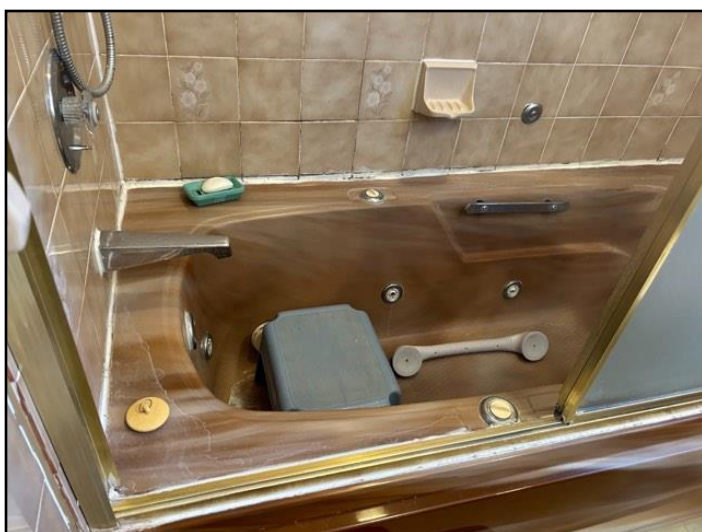
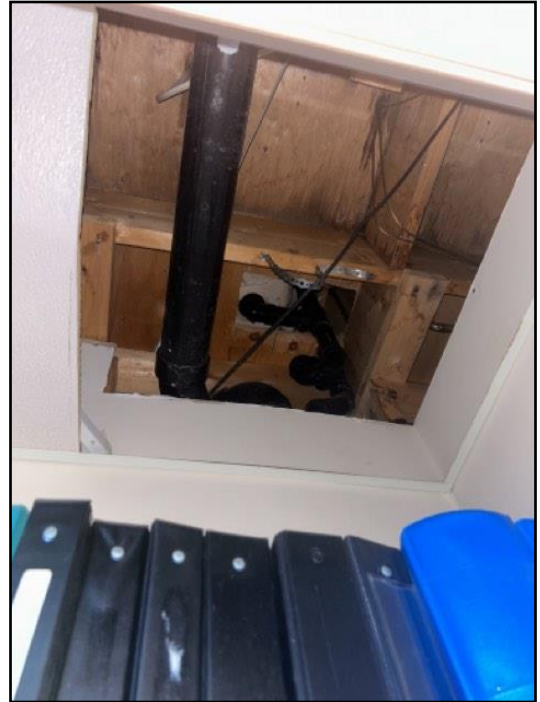
Old jet tub not tested due to its age. High concerns for leaks.

Tile at ceiling below tub removed.

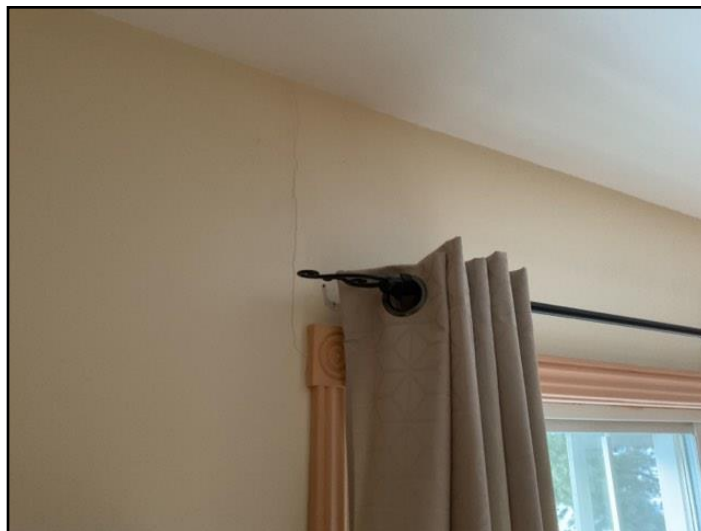
104.

**28. Condition:** • Cracking above back patio door. Possibly due to frost movement of deck.

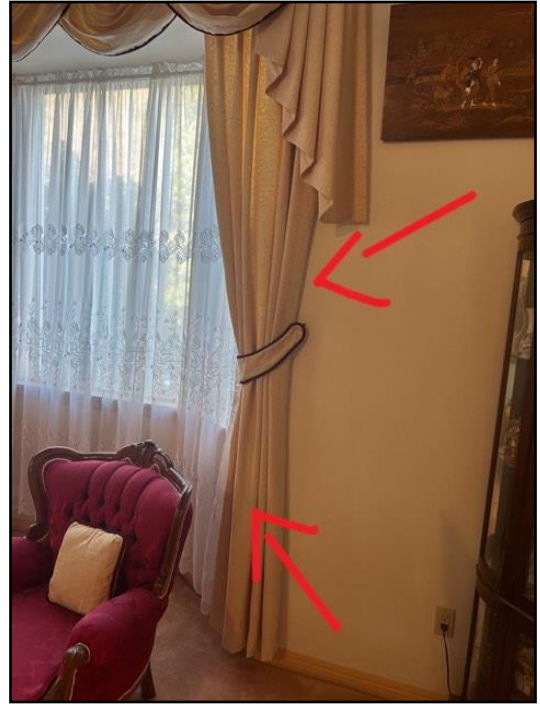
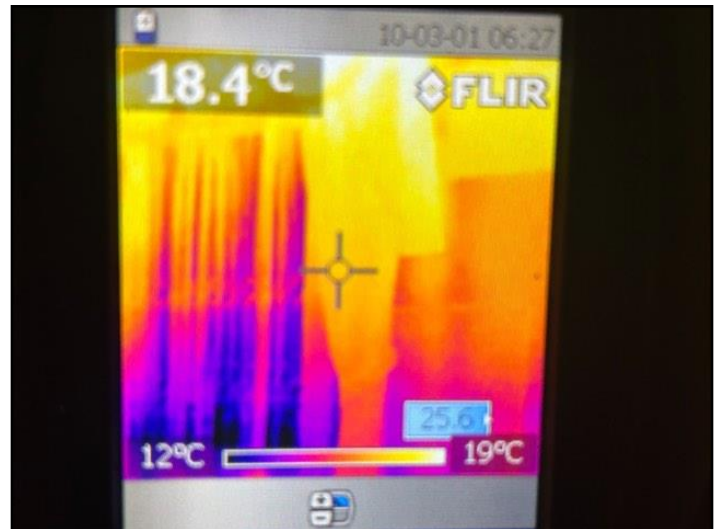
**29. Condition:** • Cracking noted by front living room window. Window glass broken. Window is rotted from moisture. Budget for possible damage to window frame when window replaced. Replacing bay window with flat window a better option. Checked with thermal camera. Nothing abnormal detected at time of inspection.

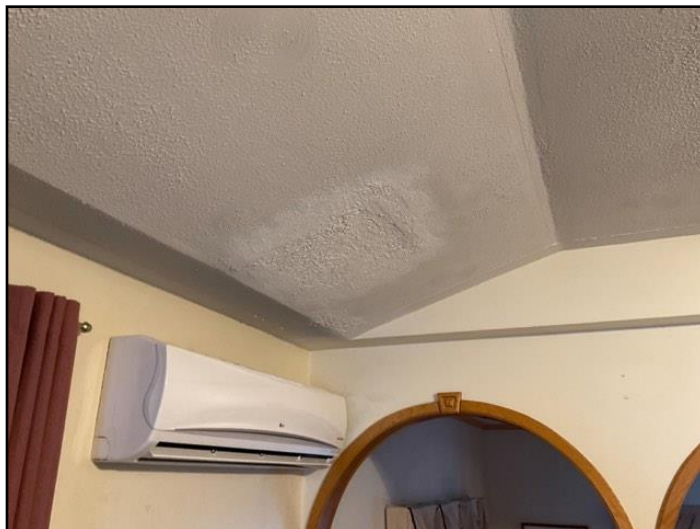
111.

30. Condition: • Patched from past wood stove chimney by heat pump.

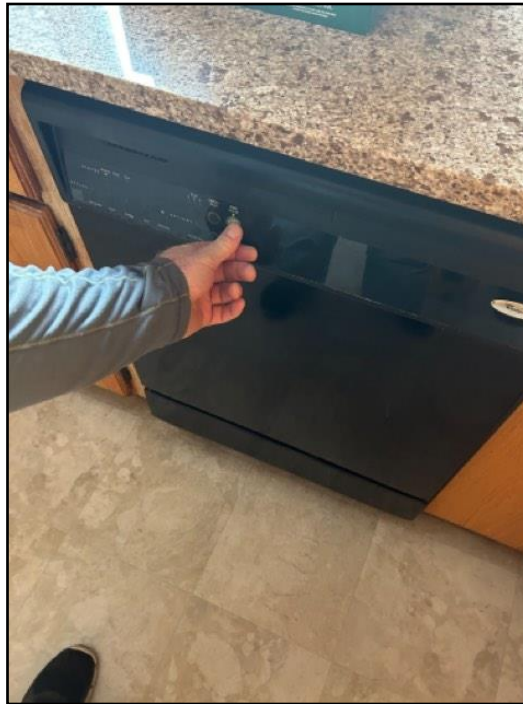
113. Dishwasher

Dishwasher tested. Unit old. Budget for future replacement.

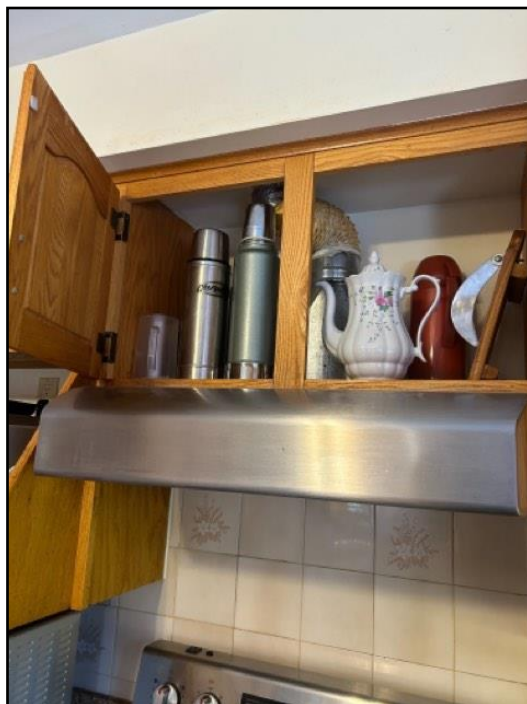
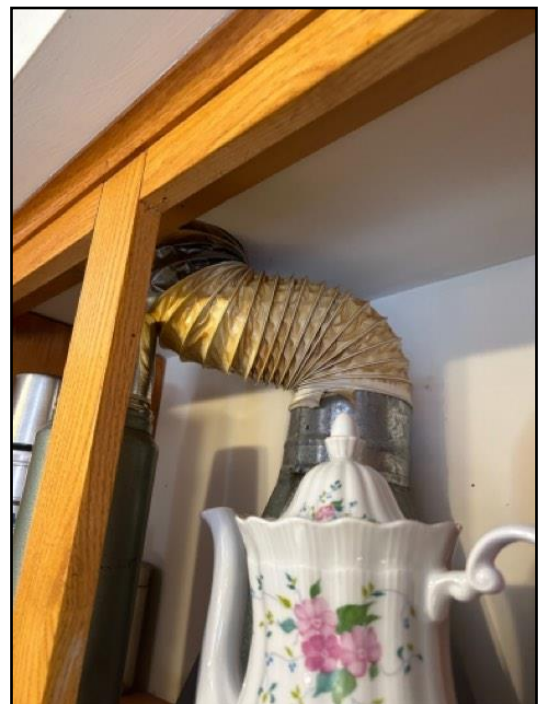
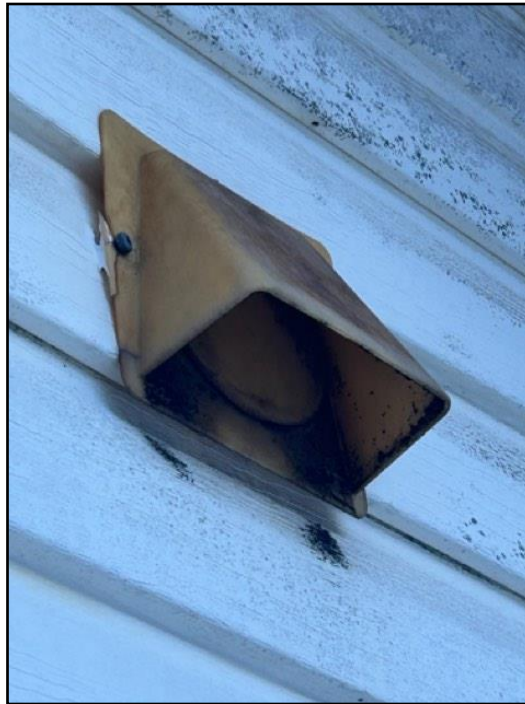
**Kitchen ventilation:** • Kitchen fan has plastic pipe. When tested exterior vent not opening. Possibly stuck of pipe has become damaged inside wall.  
Suggest replacing pipe.
