# INSPECTION REPORT

For the Property at:  
**135 SUTTON STREET**  
FREDERICTON, NB E3B 6L4

Prepared for: RASHMI HAWLEY & TUSHAR PISHE  
Inspection Date: Wednesday, February 21, 2024  
Prepared by: Dan Ferguson

RE: Report No. 1221  
135 Sutton Street  
Fredericton, NB  
E3B 6L4

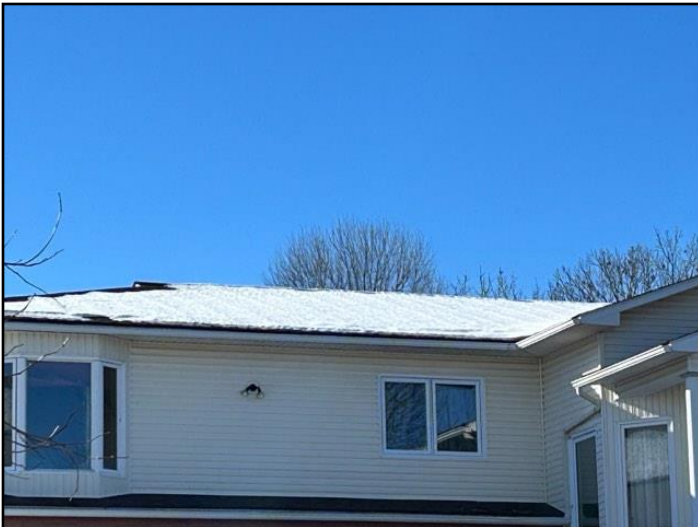
1. Snow

Snow on roof at time of inspection. Shingles not fully exposed to view or inspect.

Ice layer under now. Not safe to walk on roof.

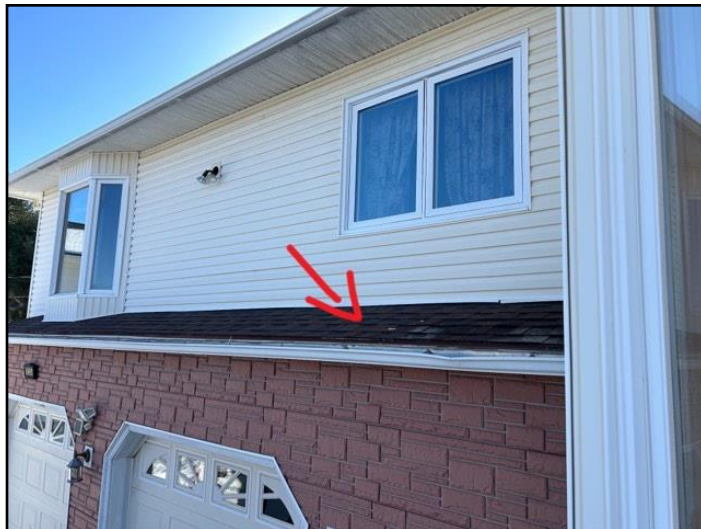
10.

3. **Condition:** • Gutters dipped at front and left side. Spillage noted. Have corrected.

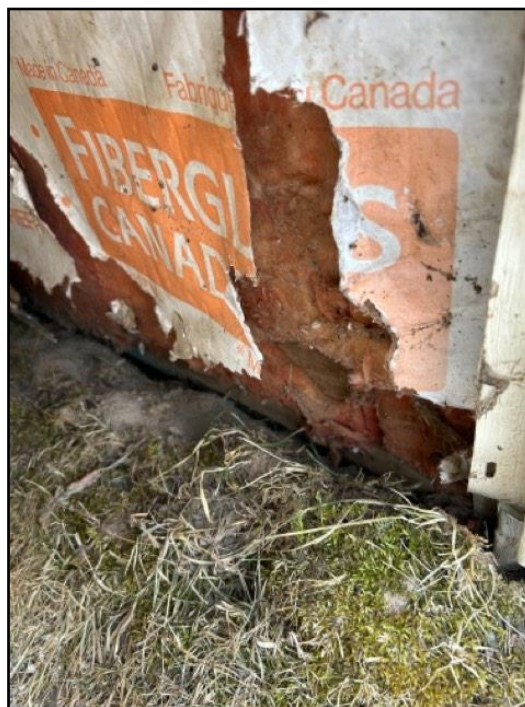
12.

4. **Condition:** • Siding at back left side of house damaged from frost heaving. This has opened up wood behind siding to water damage.  
Have this repaired.

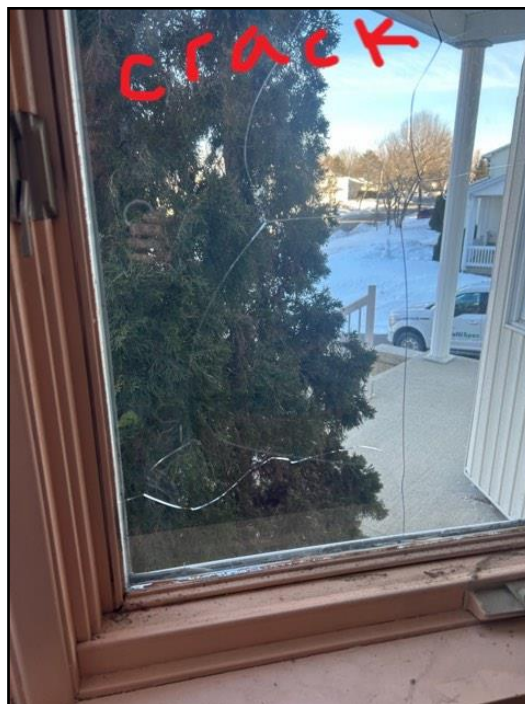
14.

**5. Condition:** • Original windows in home. Some damaged, multiple seals failed, rotted and opening devices don't work. Budget for future replacement of windows in house. Get estimates.

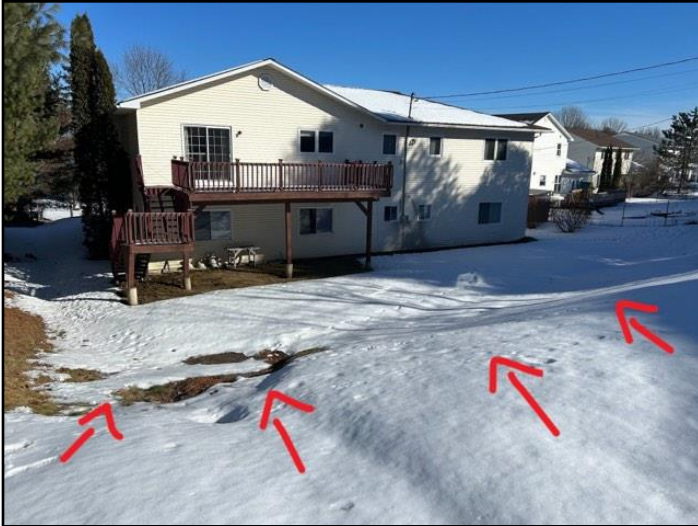
25.

**8. Condition:** • Large hill at back. Be aware when water drains towards house it raises potential for basement leaks and frost movement.

Owner had drainage pipe installed at back to help.

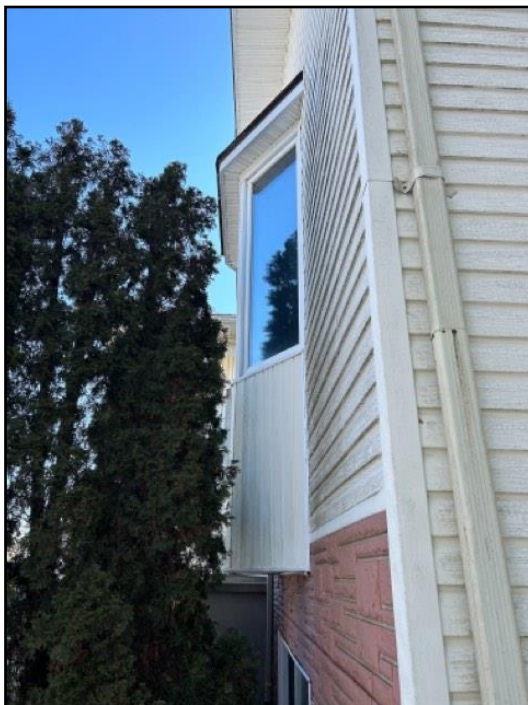
27.

**General:** • Trees touching house and roof. Have cut back.  
Fallen tree at upper back hill.

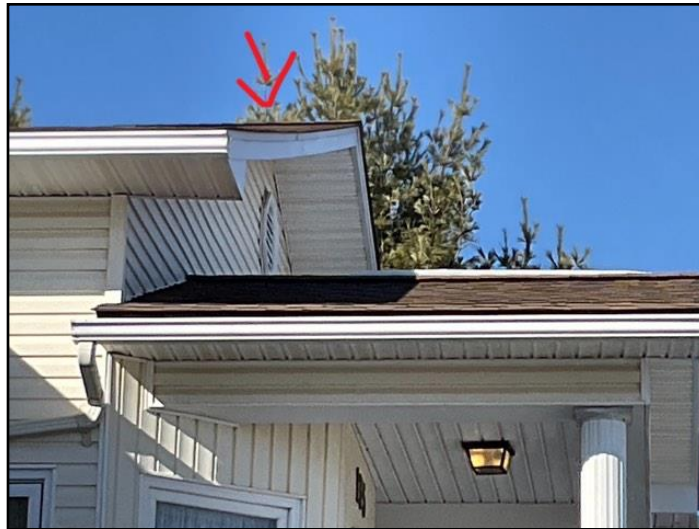
34.

**Soffit (underside of eaves) and fascia (front edge of eaves):** • Dip at front side of house.

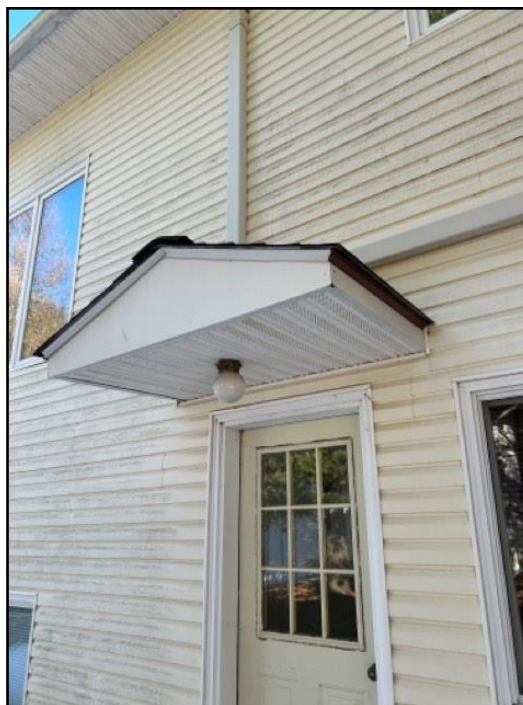
43.

**General:** • Roof over right side exit not very secure. Flimsy when pushed on.

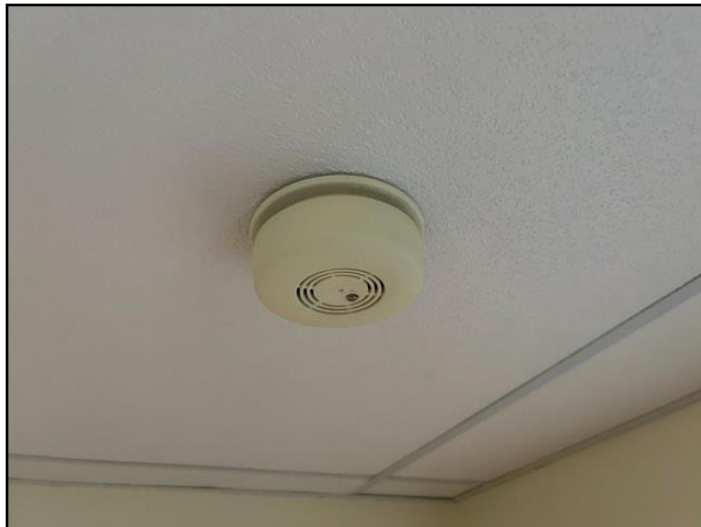
56. *Past life expectancy*

**DISTRIBUTION SYSTEM \ Smoke alarms (detectors)****17. Condition:** • Past life expectancy

Replace smoke detectors.

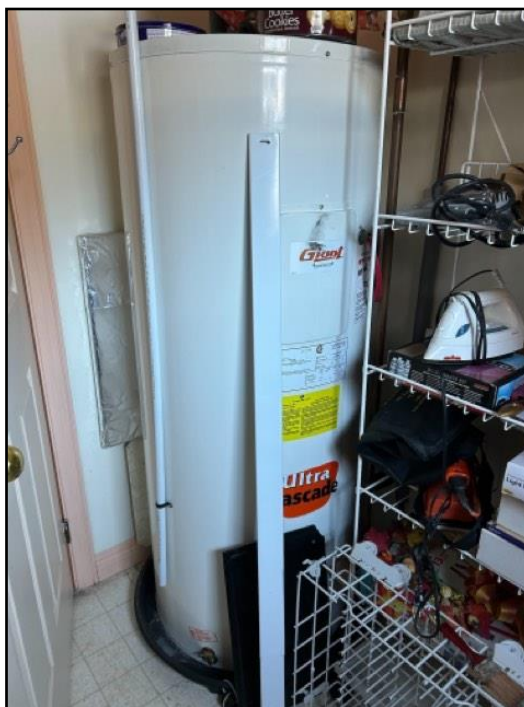
68. 9 years

**Water heater typical life expectancy:** • 10 to 15 years

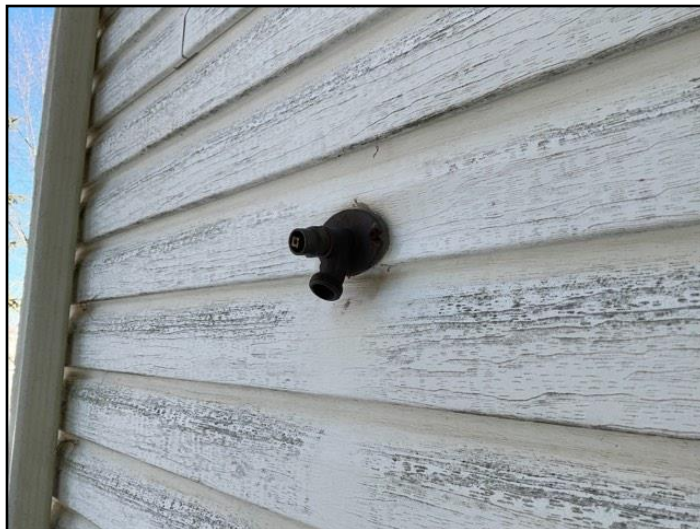
69. Present

Tap at right side of home needs new handle.

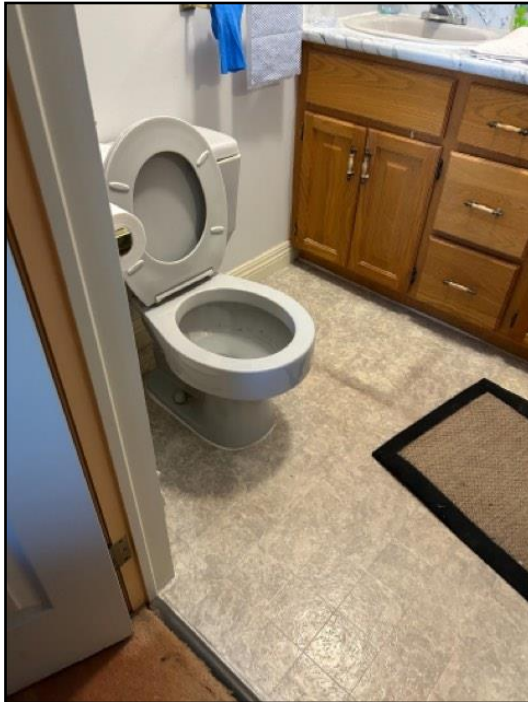
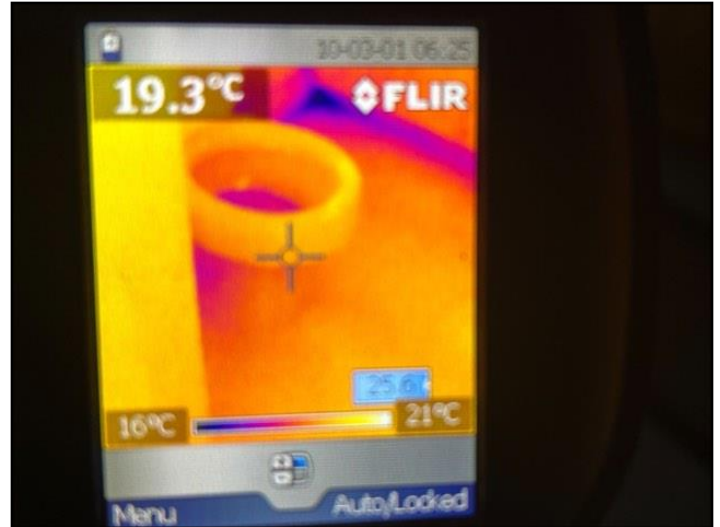
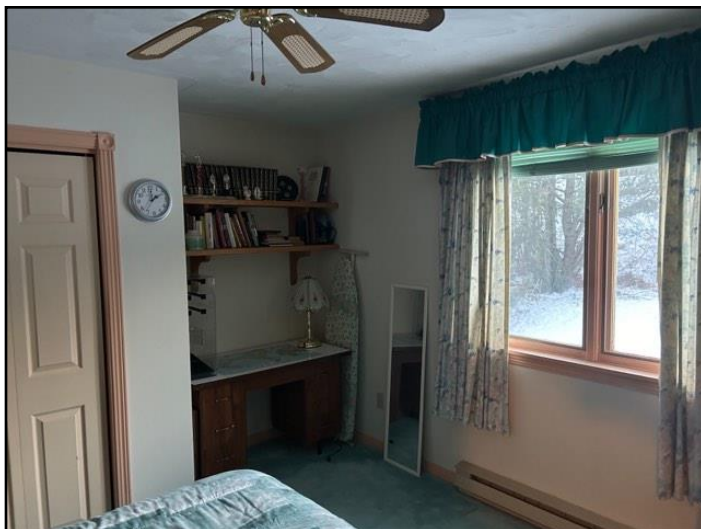
24. **Condition:** • Thermal camera used in multiple areas. Nothing abnormal noted at time of inspection.

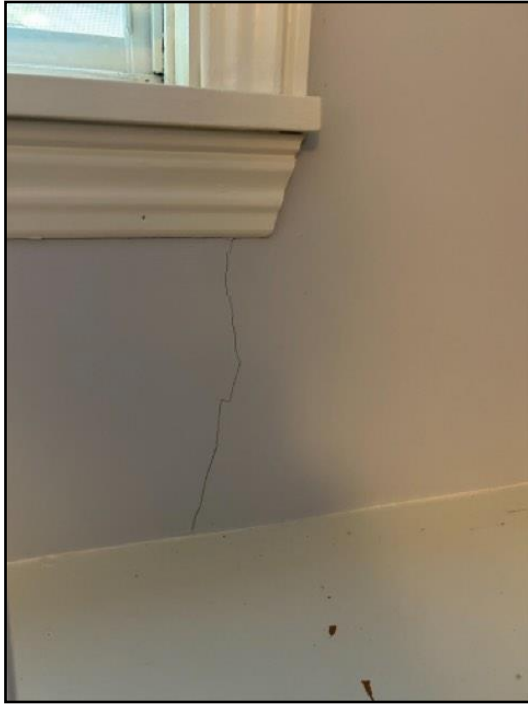
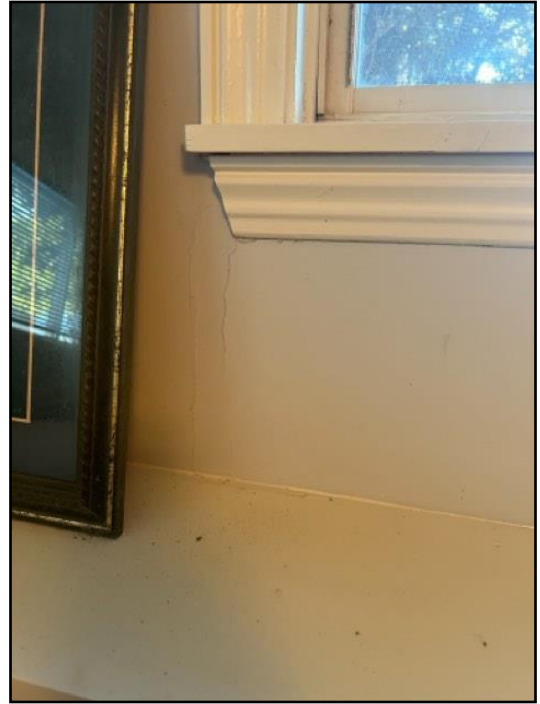
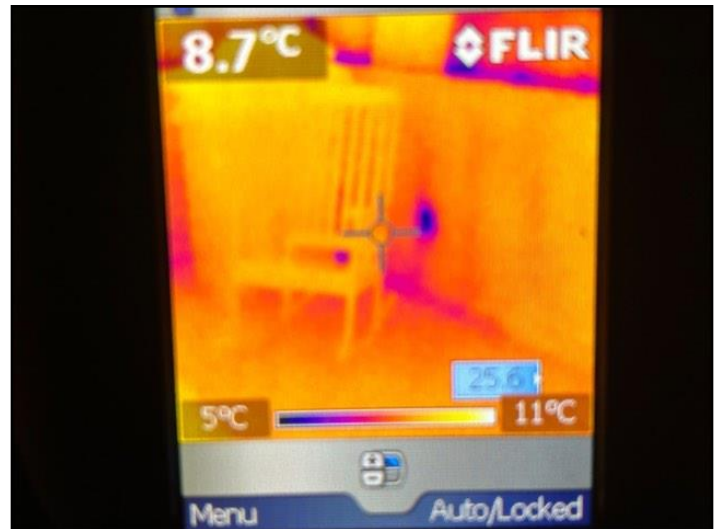
**27. Condition:** • Cracking noted around basement front left bedroom windows. May have been some past frost movement due to downspout draining directly beside foundation.

Moisture meter used at time of inspection as well as thermal camera. Nothing abnormal detected.

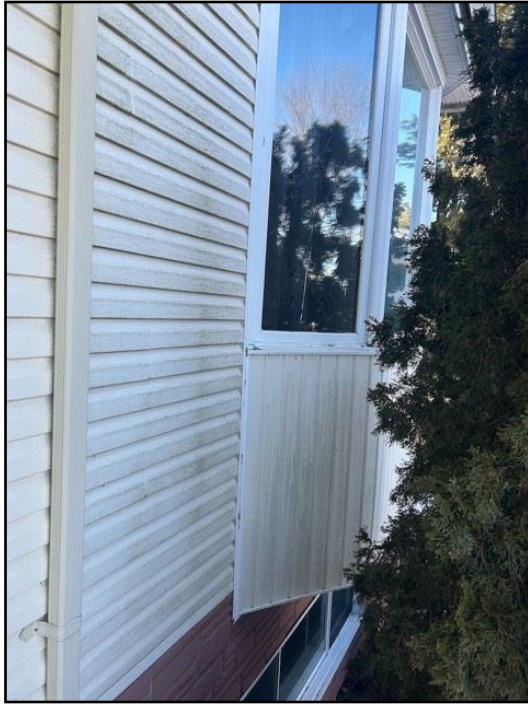
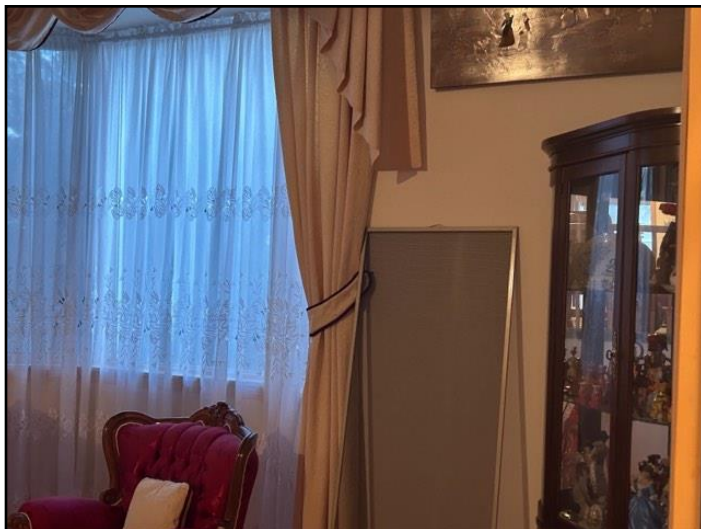
**29. Condition:** • Cracking noted by front living room window. Window glass broken. Window is rotted from moisture. Budget for possible damage to window frame when window replaced. Replacing bay window with flat window a better option. Checked with thermal camera. Nothing abnormal detected at time of inspection.

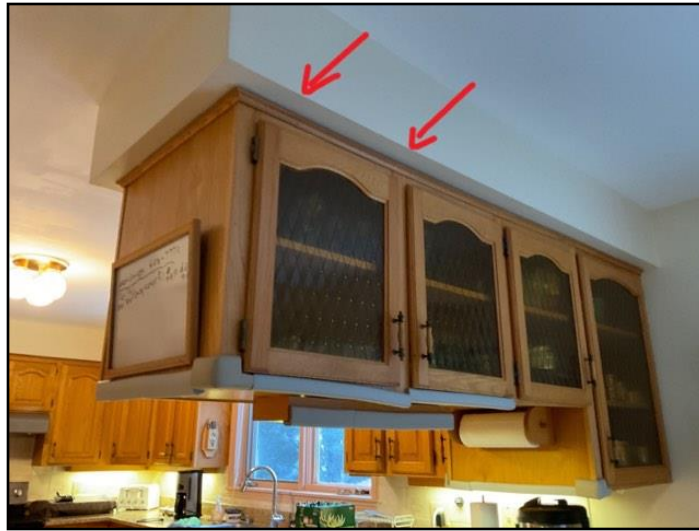
119.

**Counters and cabinets:** • Hanging cabinet looks to be pulling away from ceiling. Have secured better. Watch head contact as cabinet sits low.

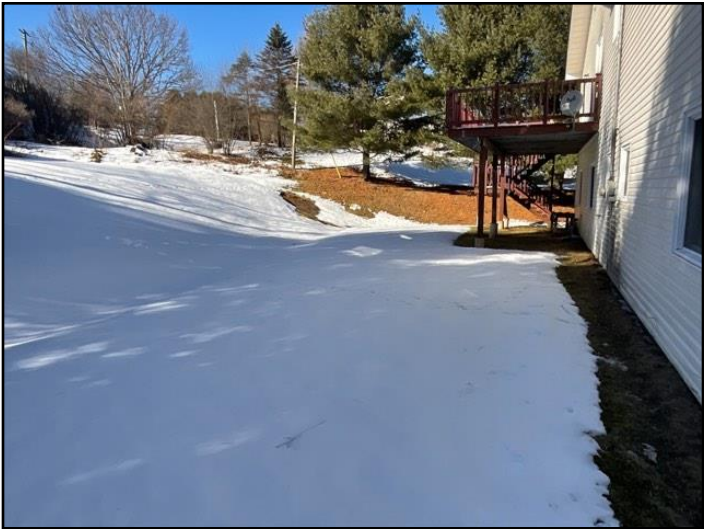
- Sunny
  - Snow
- Snow on grounds at time of inspection.

120. Snow
